**CREEP-RUPTURE AND FATIGUE BEHAVIOR OF A NOTCHED
OXIDE/OXIDE CERAMIC MATRIX COMPOSITE AT ELEVATED
TEMPERATURE**

THESIS

Barth H. Boyer, Lieutenant Commander, USN
AFIT/GAE/ENY/08-J01

AIR FORCE INSTITUTE OF TECHNOLOGY

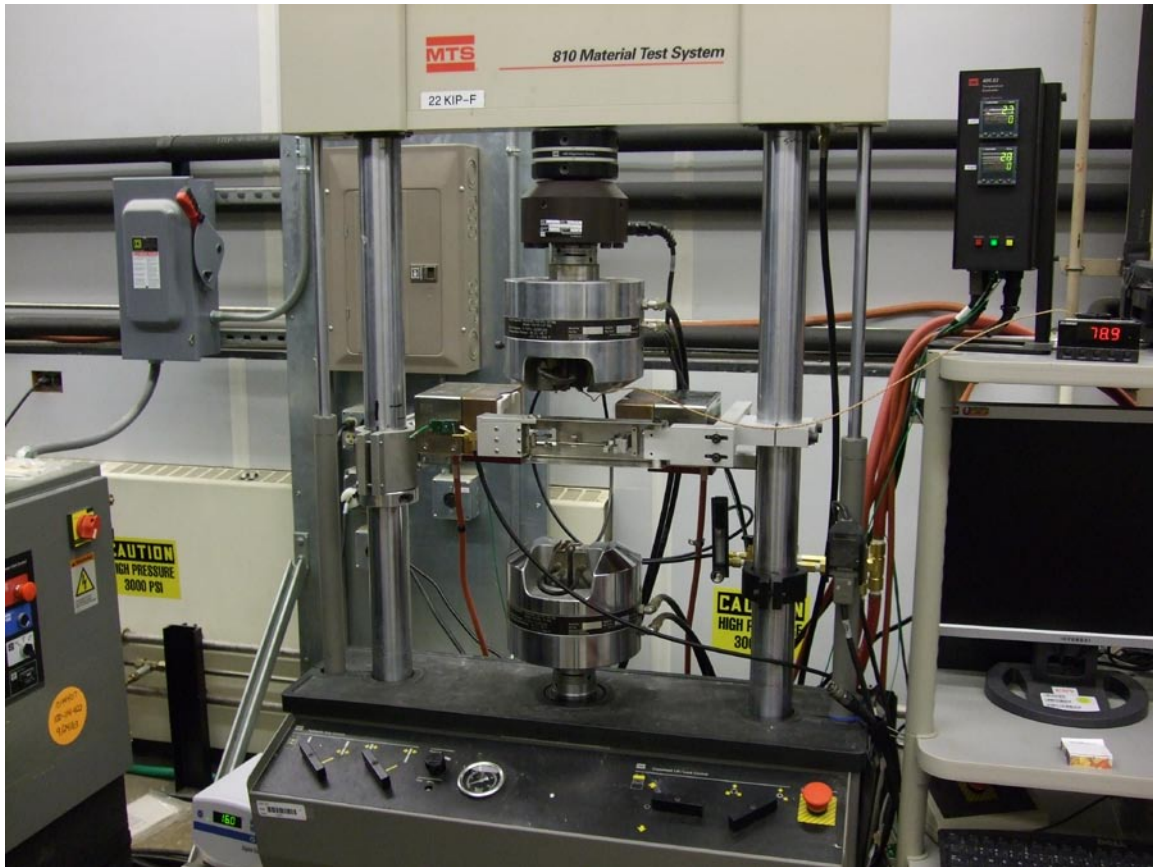
Figure 11. MTS 810 Test Apparatus

were aligned via strain gauge technique to ensure no bending or torsional forces were exerted on the specimens.

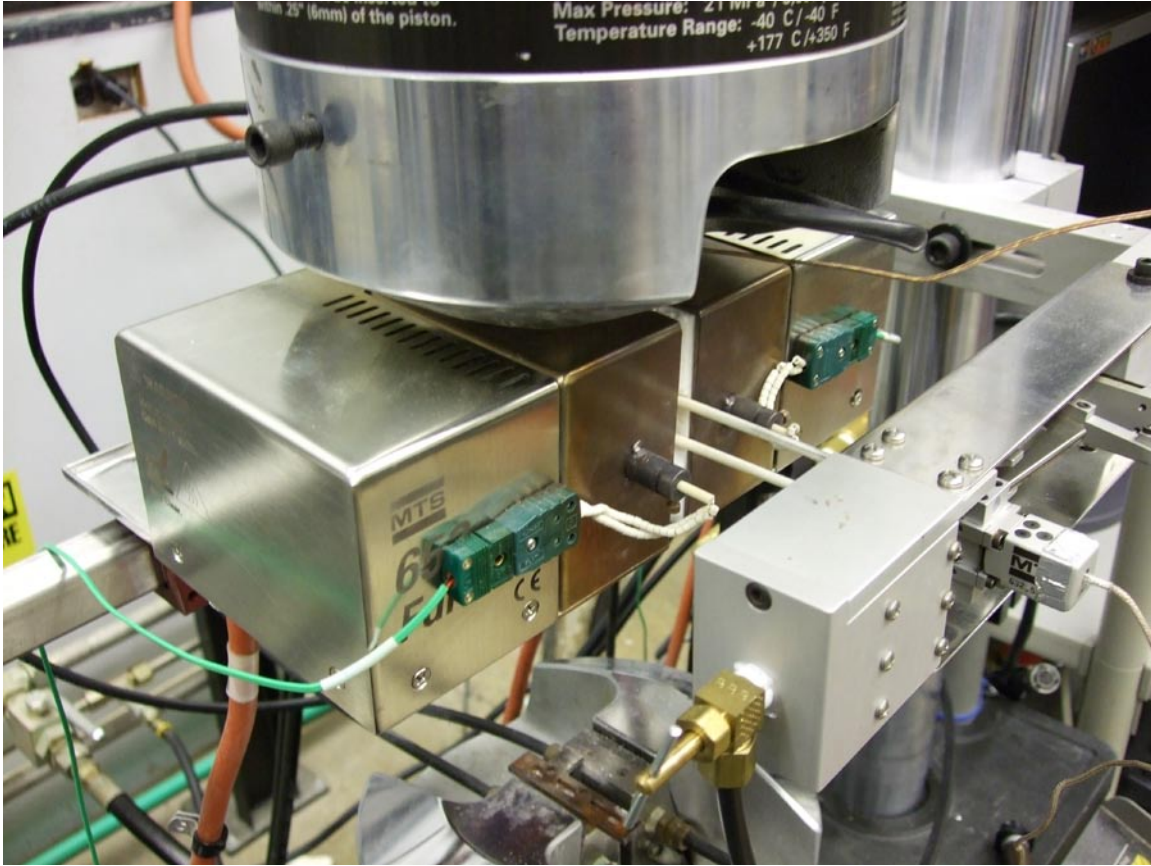
Figure 12. Extensometer Assembly

Load and strain data were collected in all tests. Load data was collected by a MTS 661 Force Transducer and strain data was collected via a MTS 632.53E-14 high temperature extensometer. The extensometer consisted of two 3.5mm diameter ceramic rods with an overall gage length of 12.7mm. The extensometer was calibrated with an MTS 650.03 Extensometer Calibrator. The extensometer was held on the specimens with simple spring tension. The full extensometer assembly includes the following: heat shield, an air diffuser (for constant cooling air), and a three axis spring positioning system. Figure 12 shows the extensometer assembly.

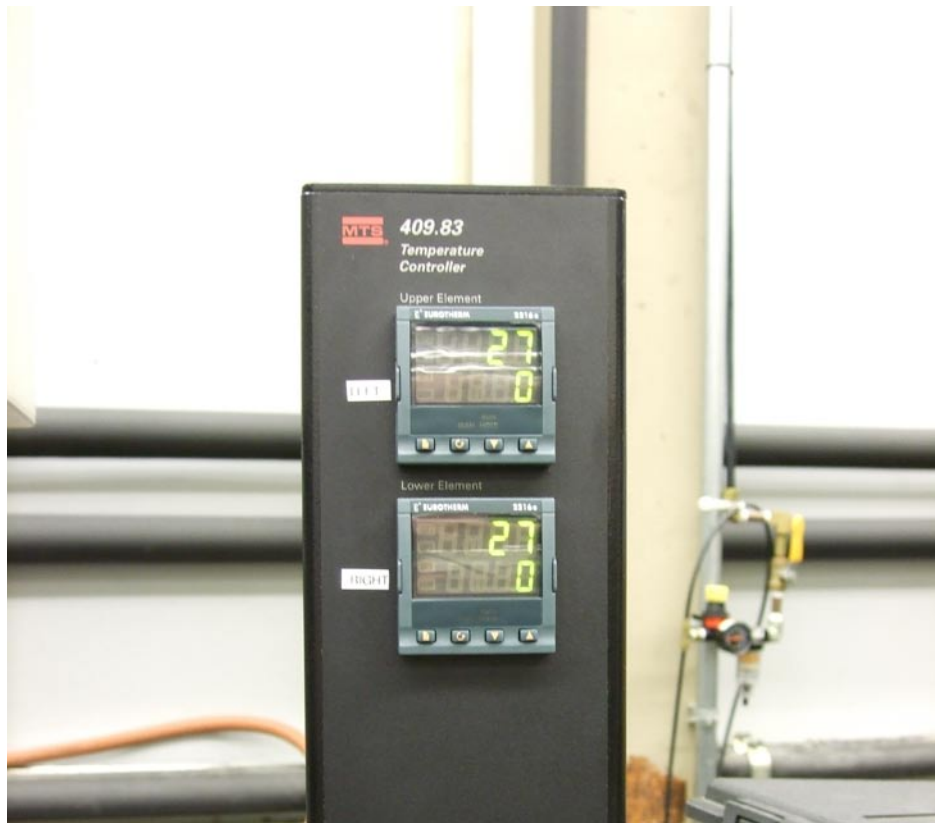
Figure 13. MTW409 Temperature Controller

The test temperature set point was applied via a PID control algorithm to each furnace element using feedback from the control thermocouples. High temperature cloth insulation was used to protect the top of the furnace from the grips and to reduce air infiltration in the gap on top of the ovens. Note that the displayed temperature by the furnace controllers was not necessarily the actual specimen temperature. This was calculated separately as will be discussed later. Figure 13 below shows the temperature controller.

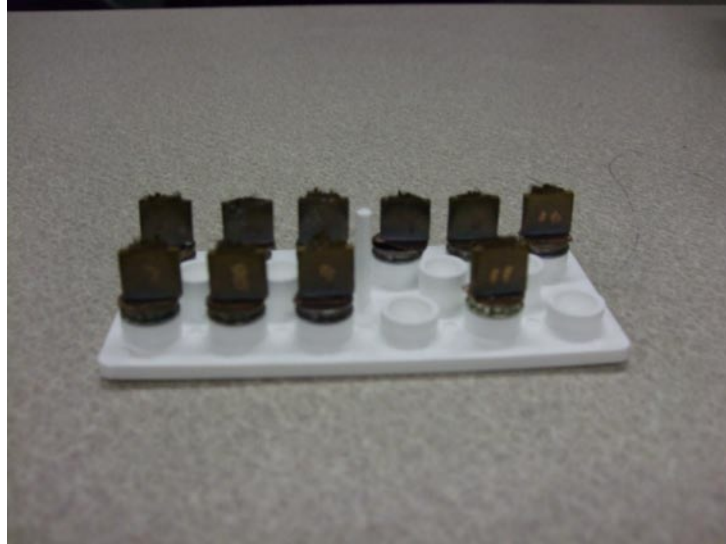
Figure 17. Specimens after gold coating.

The specimens used in this study were coated with a layer of gold to reduce surface charge buildup. This gold coating was applied via the SPI-Module 11428 coater. Specimens were first cut to a length of 1cm below the lowest fracture surface with an MTI EC400CNC saw with a water cooled 3.5 inch diamond impregnated blade. Next,

the specimens were mounted on metal tabs via carbon tape. The mounted specimens were then placed in an evacuated chamber and a current was allowed to pass thru the gold anode vaporizing it and forming a deposit over the specimen surface. This was repeated three more times at various angles to ensure a thorough coating. Finally, a bead of silver paste was applied to the sides of the mounted specimens to provide a consistent ground.
